DEPARTMENT OF TRANSPORTATION

Quality Assurance and Source Inspection

Contract #: 04-0120F4Cty: SF/ALA Rte: 80 PM: 13.2/13.9File #: 69.28**WELDING INSPECTION REPORT****Resident Engineer:**Siegenthaler, Peter**Address:** 333 Burma Road**City:** Oakland, CA 94607**Report No:** WIR-023085**Date Inspected:** 04-Apr-2011**Project Name:** SAS Superstructure**OSM Arrival Time:** 1500**Prime Contractor:** American Bridge/Fluor Enterprises, a JV**OSM Departure Time:** 300**Contractor:** Zhenhua Port Machinery Company, Ltd (ZPMC), Changxing Island **Location:** Shanghai, China**CWI Name:** Mr. Li Yan Hua**CWI Present:** Yes No**Inspected CWI report:** Yes No N/A**Rod Oven in Use:** Yes No N/A**Electrode to specification:** Yes No N/A**Weld Procedures Followed:** Yes No N/A**Qualified Welders:** Yes No N/A**Verified Joint Fit-up:** Yes No N/A**Approved Drawings:** Yes No N/A**Approved WPS:** Yes No N/A**Delayed / Cancelled:** Yes No N/A**Bridge No:** 34-0006**Component:** OBG**Summary of Items Observed:**

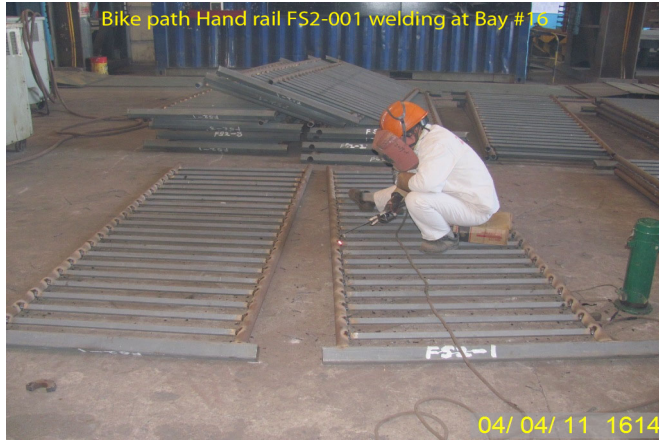
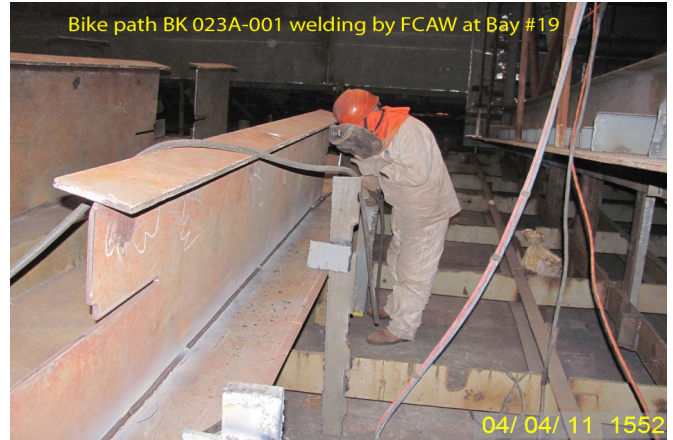
For further information see below pictures:-

Unless otherwise noted, all work observed on this date appeared to be in general compliance with the applicable

contract documents.
